AVIATION INVESTIGATION REPORT

A03P0247

LOSS OF ENGINE POWER – COLLISION WITH TERRAIN

**GEMINI HELICOPTERS INC.
BELL 204B (HELICOPTER) C-GEAP
BONAPARTE LAKE, BRITISH COLUMBIA
17 AUGUST 2003**

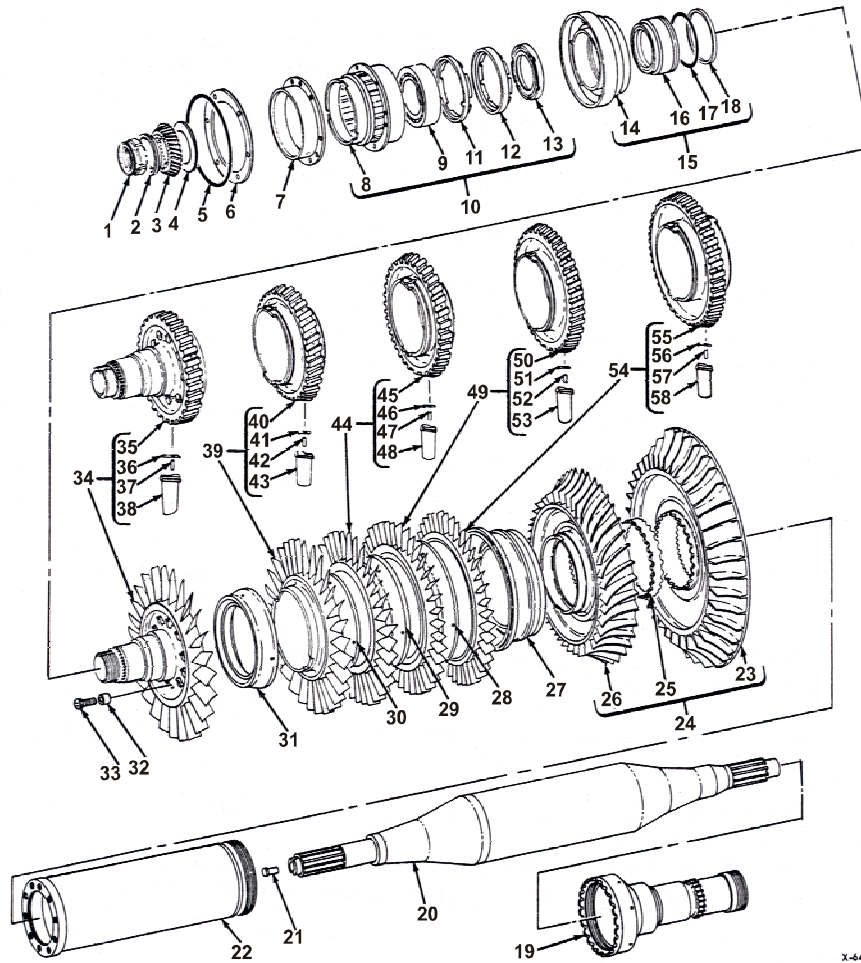
Appendix A – Compressor Rotor Assembly

Compressor Rotor Assembly - Exploded View
